**TAUNTON RIVER BASIN
TAUNTON, MASSACHUSETTS**

**MILL RIVER DAM
MA 00813**

**PHASE I INSPECTION REPORT
NATIONAL DAM INSPECTION PROGRAM**

APRIL 1979

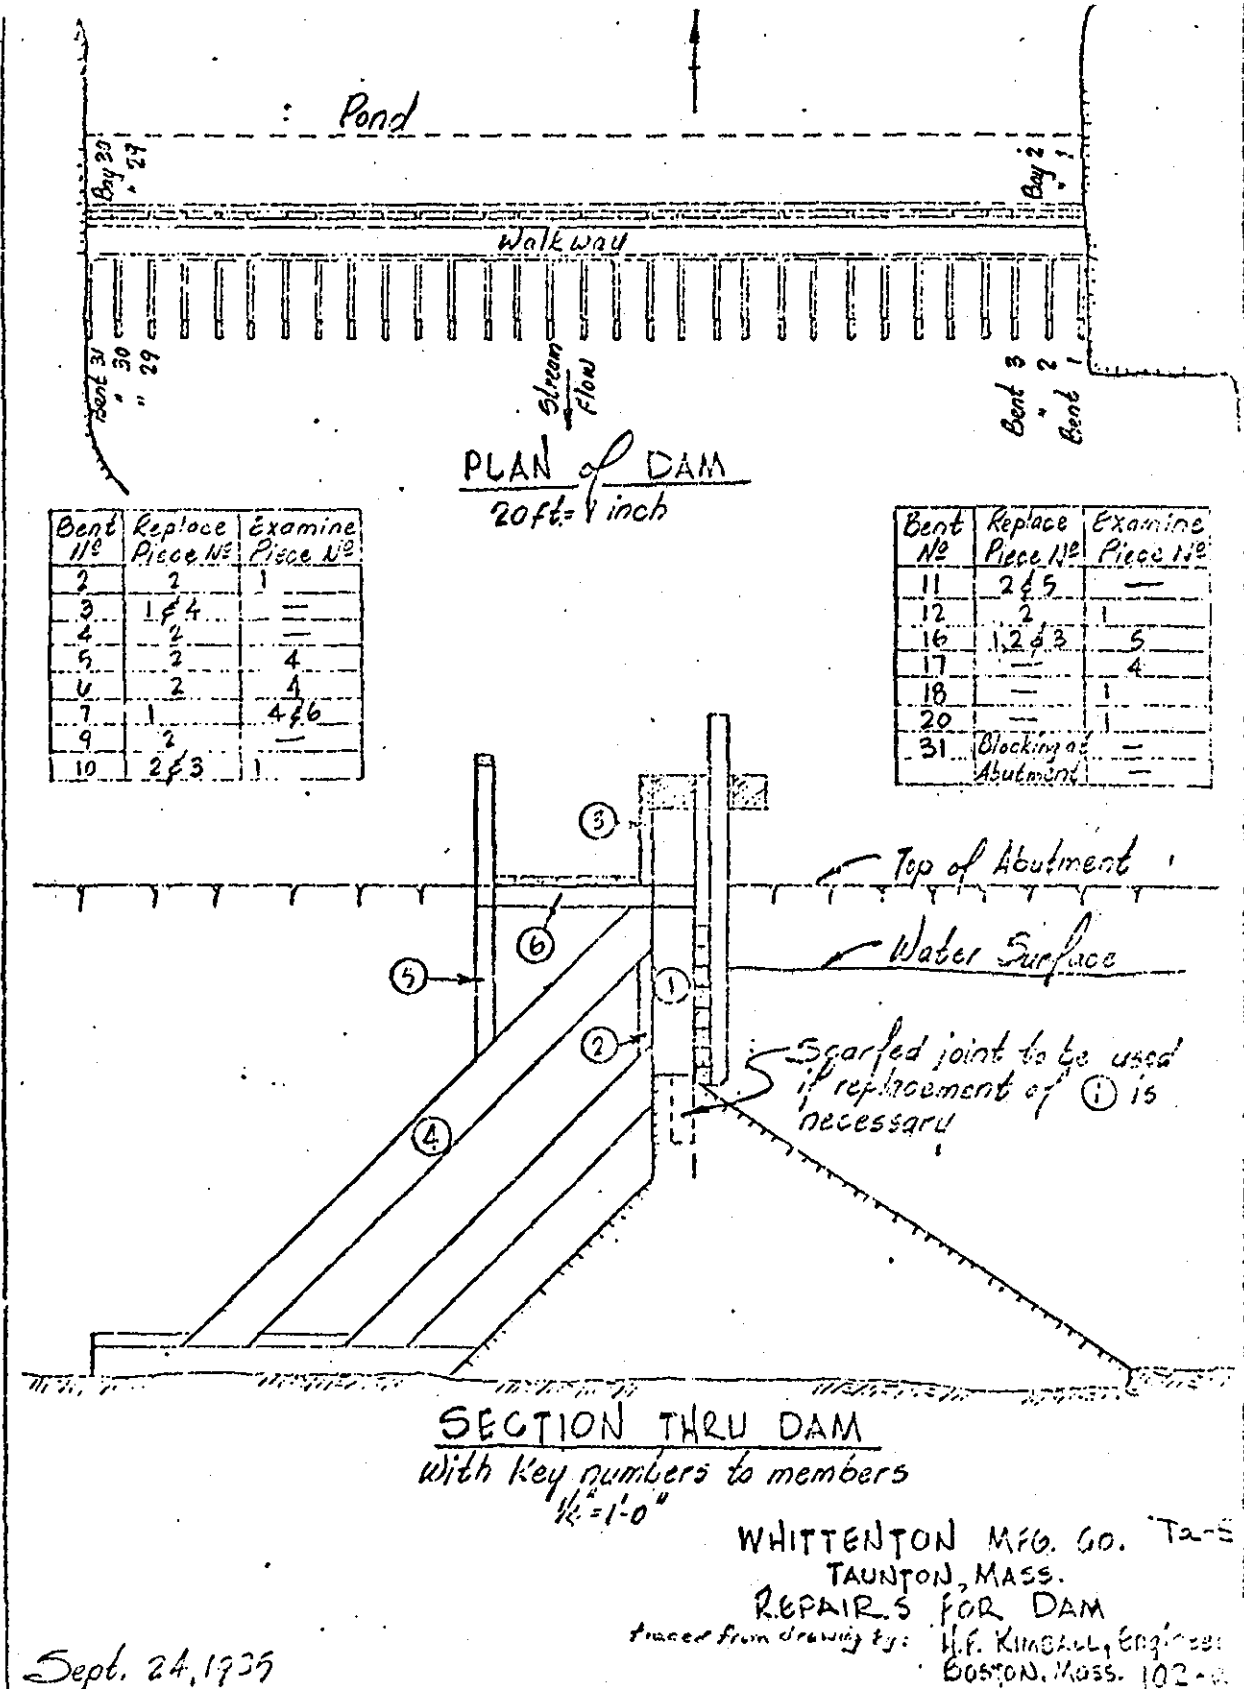
FIGURE B-3

- 2.1 General. A drawing dated September 1935 is available from the Bristol County Commissioners Office and shows proposed repair of timbers on the dam (see Figure B-3). A report on hydraulic and stability analyses conducted for Mill River (Whittendon) Dam was prepared by Metcalf & Eddy, Inc. The report is dated June 1973 and copies are available from the Owner and from Metcalf & Eddy, Inc. No other plans, specifications, or computations are available from the Owner, State, or County agencies relative to the design, construction, or repair of this dam.

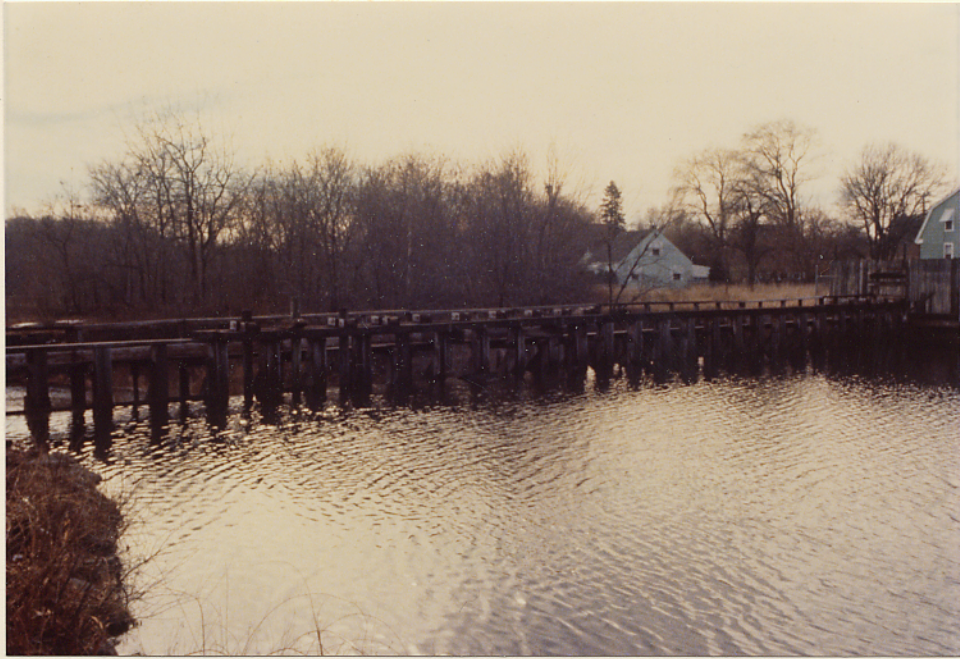
NO. 1 VIEW OF UPSTREAM FACE OF DAM

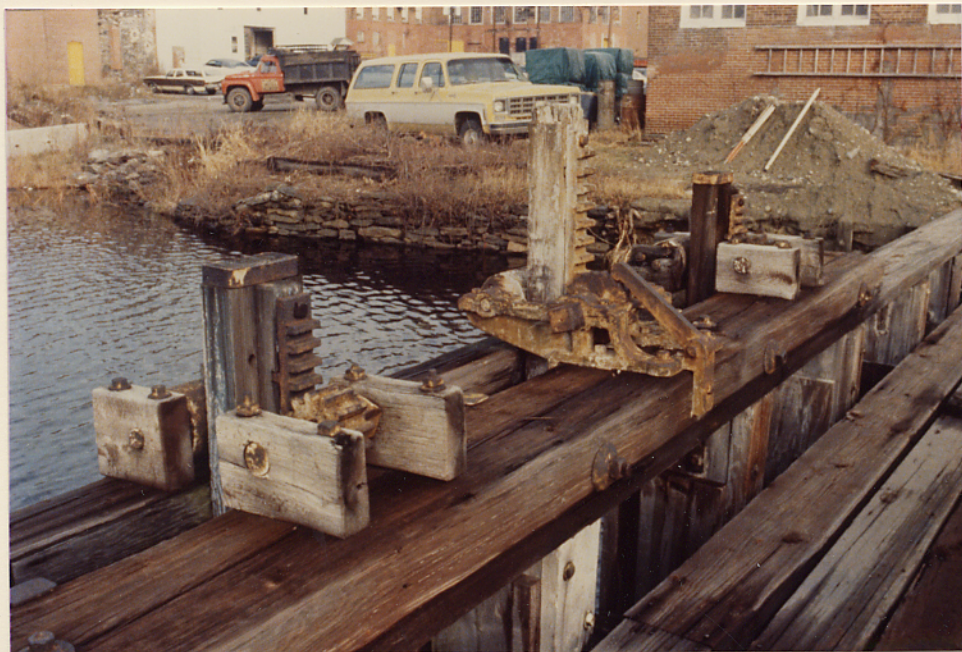
The following deficiencies were observed at the site: 23 inoperable slide gates, deterioration of the timber walkway over the spillway, leakage around and between the stoplogs and the abandoned slide gates, poor condition of the operating mechanism for the sluice gate, brush growth along the walls of the downstream channel, and collapsing stonework in the walls of the downstream channel and in the west wall upstream of the dam.

NO. 2 VIEW OF OPERATING MECHANISMS FOR SLIDE GATES

- a. Operating and Maintenance Procedures. The dam and appurtenant structures are not maintained. It is recommended that the Owner accomplish the following:
 - (1) immediately remove all of the abandoned slide gates from the spillway and lower the pond to El 55.1. The pond should be maintained at this level until the recommendations and following remedial measures are implemented.
 - (2) restore the abandoned slide gates to operating condition. At the present time, only two of the slide gates have stems, and none have operating mechanisms.

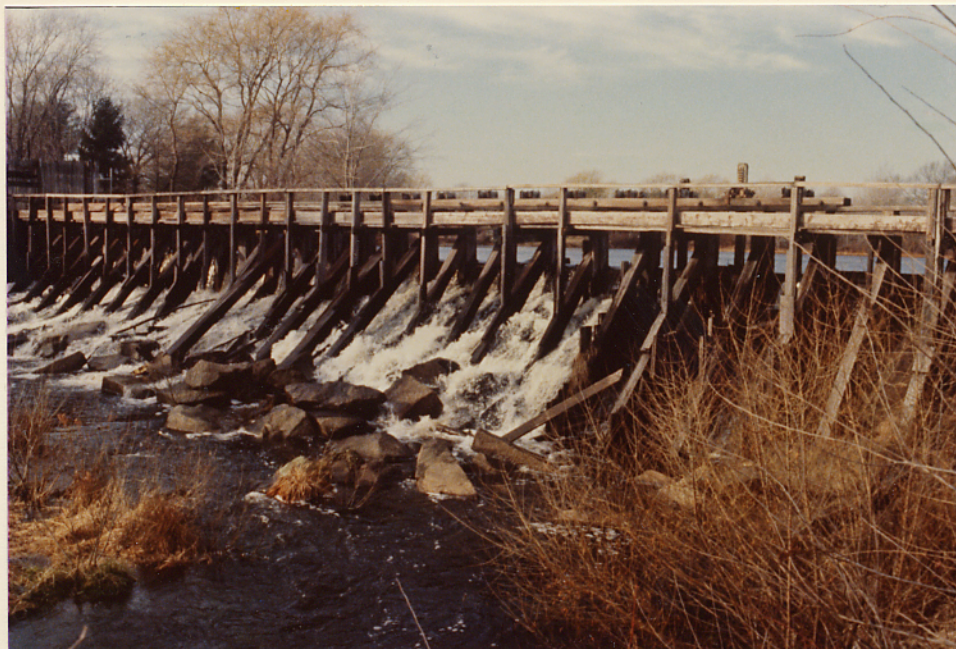
The dam is in poor condition. Seepage at the toe could not be determined due to water flowing over the crest of the spillway. The most obvious deficiencies at the site are the deterioration of the timber walkway over the spillway and the inoperable condition of the 23 abandoned slide gates. The timbers in the walkway are rotting, and at least one timber is missing. The walkway, which provides access to the stoplogs, slide gates, and sluice gate, is only marginally safe to walk on. Due to the deterioration of the timber, some leakage was observed around the guideposts of some bays. Leakage is also occurring between some stoplogs and between the boards of some slide gates. There are no hooks, eye bolts, or other means of removing the stoplogs or boards of the slide gates. The concrete on the crest and downstream slope of the spillway is pitted and eroded. Also, stonework is missing from a section of the west training wall upstream of the dam.

NO. 3 VIEW OF DOWNSTREAM FACE OF DAM

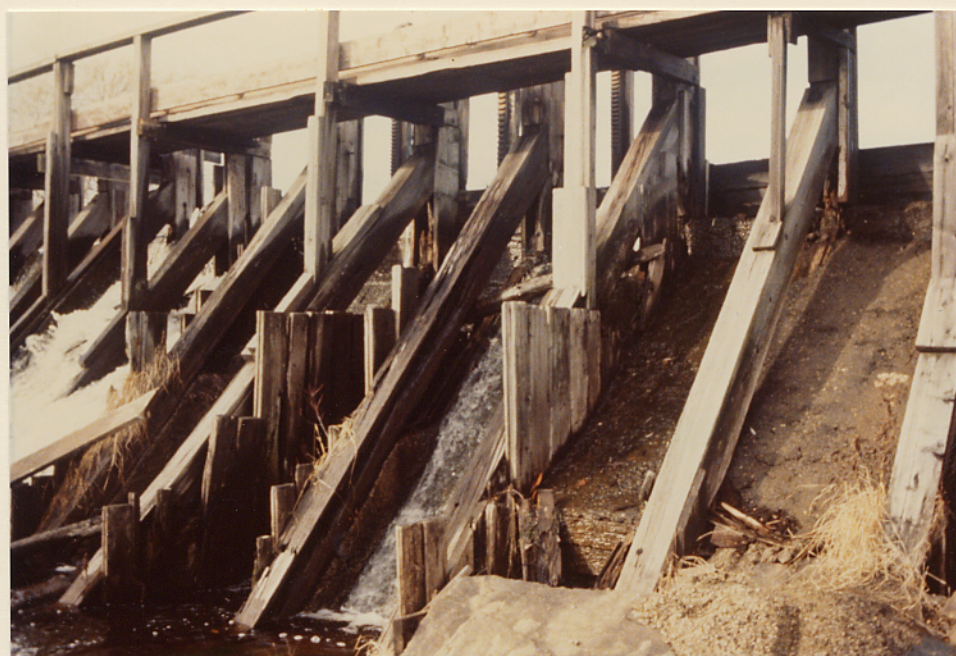
* WATER DISCHARGING OVER SPILLWAY DURING INSPECTION
concrete spillway pitted and eroded, flash boards
leaking, OPERATING STRUCTURES MISSING OR
APPARENTLY marginally operable, APPARENT LEAK
BENEATH SPILLWAY

NO. 4 DETAIL OF DOWNSTREAM FACE OF DAM

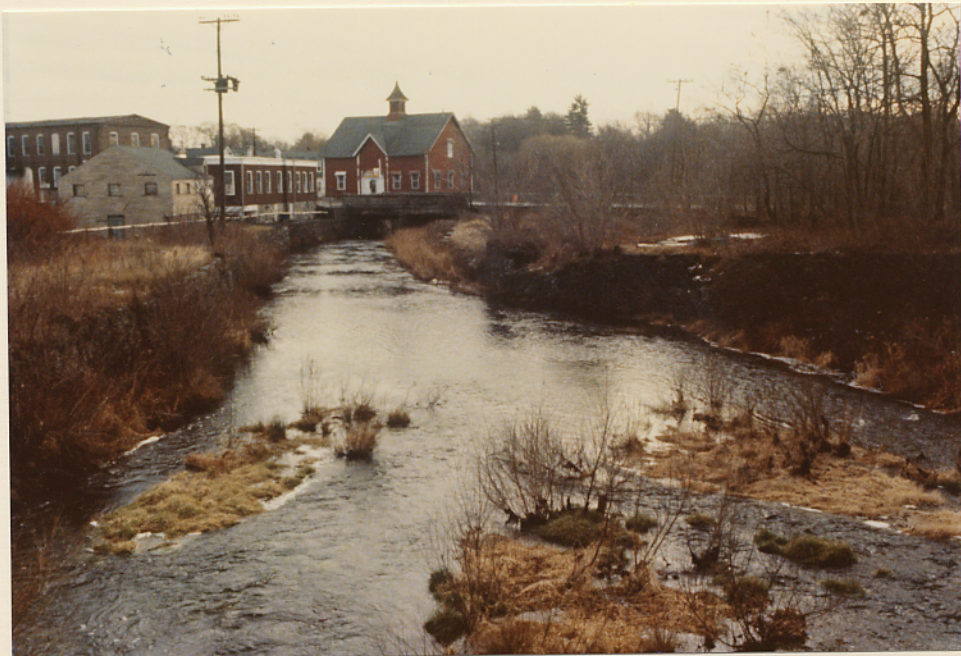
Stonework is missing from both side walls of the channel, and some sections of the west wall have partially collapsed. One section, about 60 feet downstream of the dam on the west wall, has completely collapsed.

- 4.3 Maintenance of Operating Facilities. The sluice gate which controls the only outlet for the dam is in poor condition and may not be operable. The stone side walls of the downstream channel are overgrown with brush. Some stones are missing from the walls, and sections of the west side wall are collapsing.

NO. 5 VIEW OF CHANNEL DOWNSTREAM OF DAM

- (3) restore deteriorating timbers in the walkway structure over the spillway,
- (4) restore the sluice gate to operating condition,
- (5) remove brush and small-trees growing on both sides of the downstream channel,
- (6) repair stonework on both walls of the downstream channel and on the west wall upstream of the dam,
- (7) implement a systematic program of maintenance inspections. As a minimum, the inspection program should consist of a monthly inspection of the dam and appurtenances, supplemented by additional inspections during and after severe storms. All repairs and maintenance should be undertaken in accordance with all applicable State regulations.
- (8) periodic technical inspections of this dam should be continued on an annual basis,
- (9) institute a definite plan for surveillance and a warning system during periods of unusually heavy rains and/or runoff.

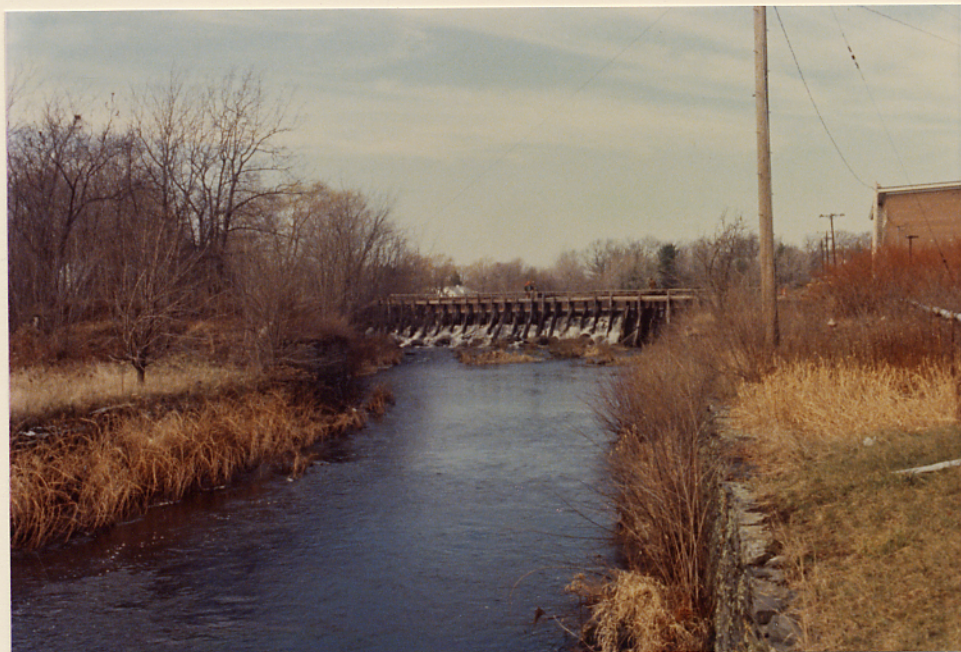
**NO. 6 VIEW OF DAM AND DOWNSTREAM CHANNEL
FROM WHITTENTON STREET**
